MTMC REPORT TE 77-63

RAIL AND MOTOR OUTLOADING CAPABILITY STUDY  
FORT IRWIN, CALIFORNIA

May 1978

MILITARY TRAFFIC MANAGEMENT COMMAND  
TRANSPORTATION ENGINEERING AGENCY

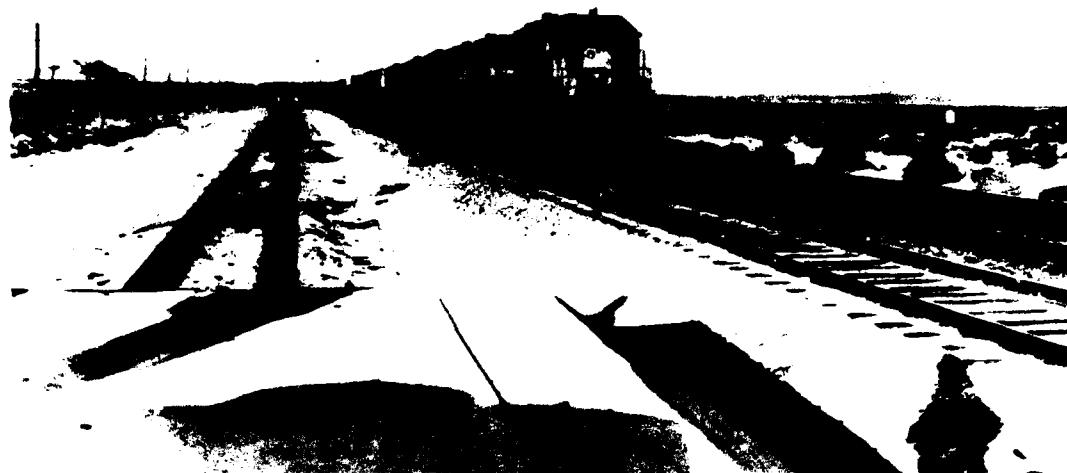
Figure 2. Manix (looking east from ramp).

The site, consisting of a spur adjacent to a 5,400-foot passing track and a main line, has a capacity of twenty-nine 60-foot cars. It has a concrete end ramp, which is surrounded by lightly gravelled sand. No lighting exists here and the staging area is good. A problem exists because of a petroleum pipeline buried alongside this trackage. Heavy vehicles must be moved with care so that they do not dig away the sand and damage this line. The track itself is in good condition<sup>2/</sup> and no repairs are necessary, as shown in figures 2 through 5.

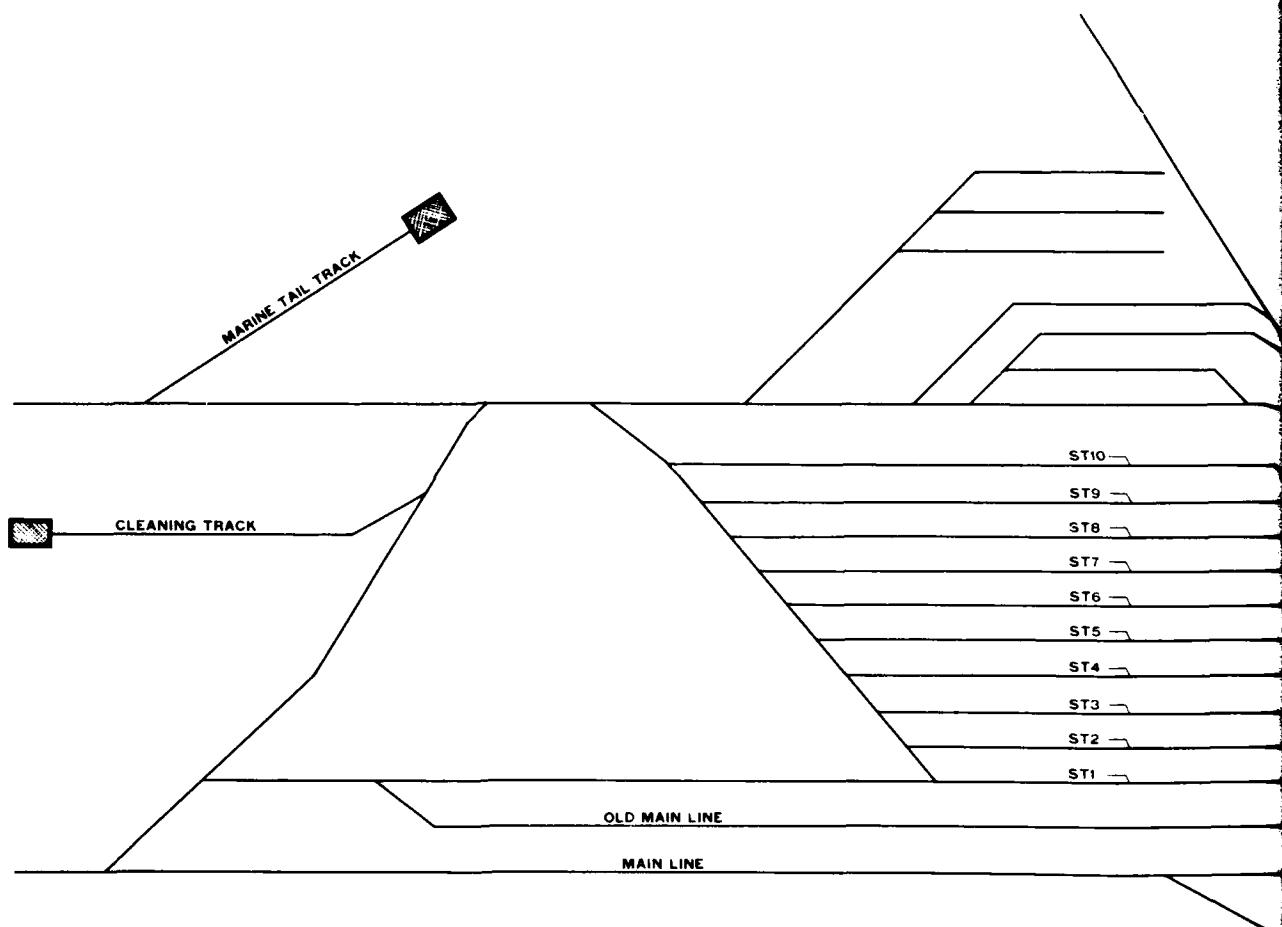
Figure 7. Yermo - Union Pacific Railroad.

The Union Pacific Railroad classification yard at Yermo is 11 miles due east of Barstow along old Route 466. This site has three spurs--cleaning, "Y," and Marine tail tracks--that can be used for end loading and a house track that can also be used with some modification. The total capacity of these tracks is eighty-four 60-foot cars (fig 7).

The marine tail track, located at the northwestern part of the yard, has a dirt ramp at one end that needs minor repairs. This track, shown in figures 13 and 14 is in good condition and its staging area is excellent. The track capacity is twenty-six 60-foot cars.

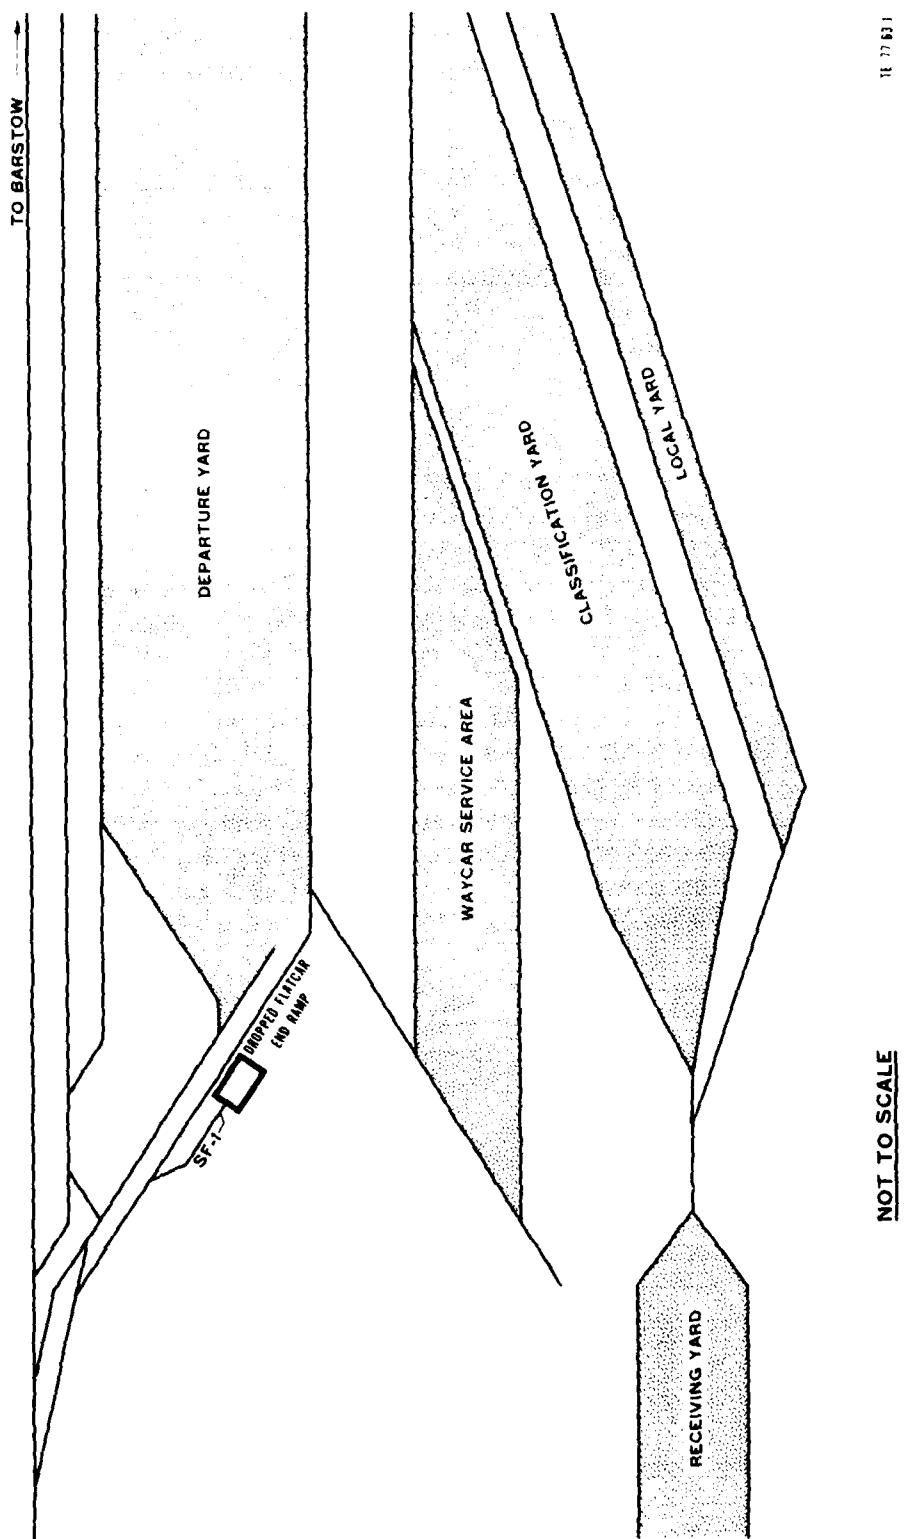
Figure 24. ATSF - new classification yard.

ATSF has a huge computer-controlled classification yard just outside of Barstow (fig 24). For practical purposes, only one spur, with a capacity of five 60-foot cars, is available for end loading (SF-1).

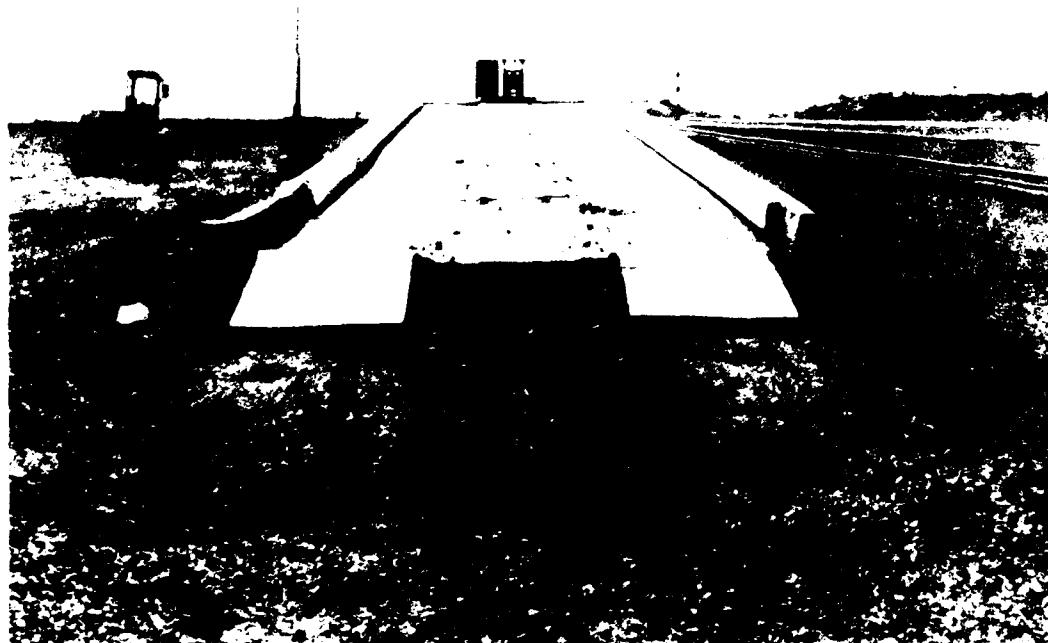
Figures 25 and 26 show a flatcar dropped on one end to serve as an end ramp. The surface is a gravel layer topping a dirt substrate. The staging area is excellent and road access is good. The track (fig 27) is in excellent condition and is 38 miles distant from Fort Irwin. The total capacity of all three ATSF sites is fifty-two 60-foot cars.

Figure 26. End view of dropped flatcar serving as a ramp.

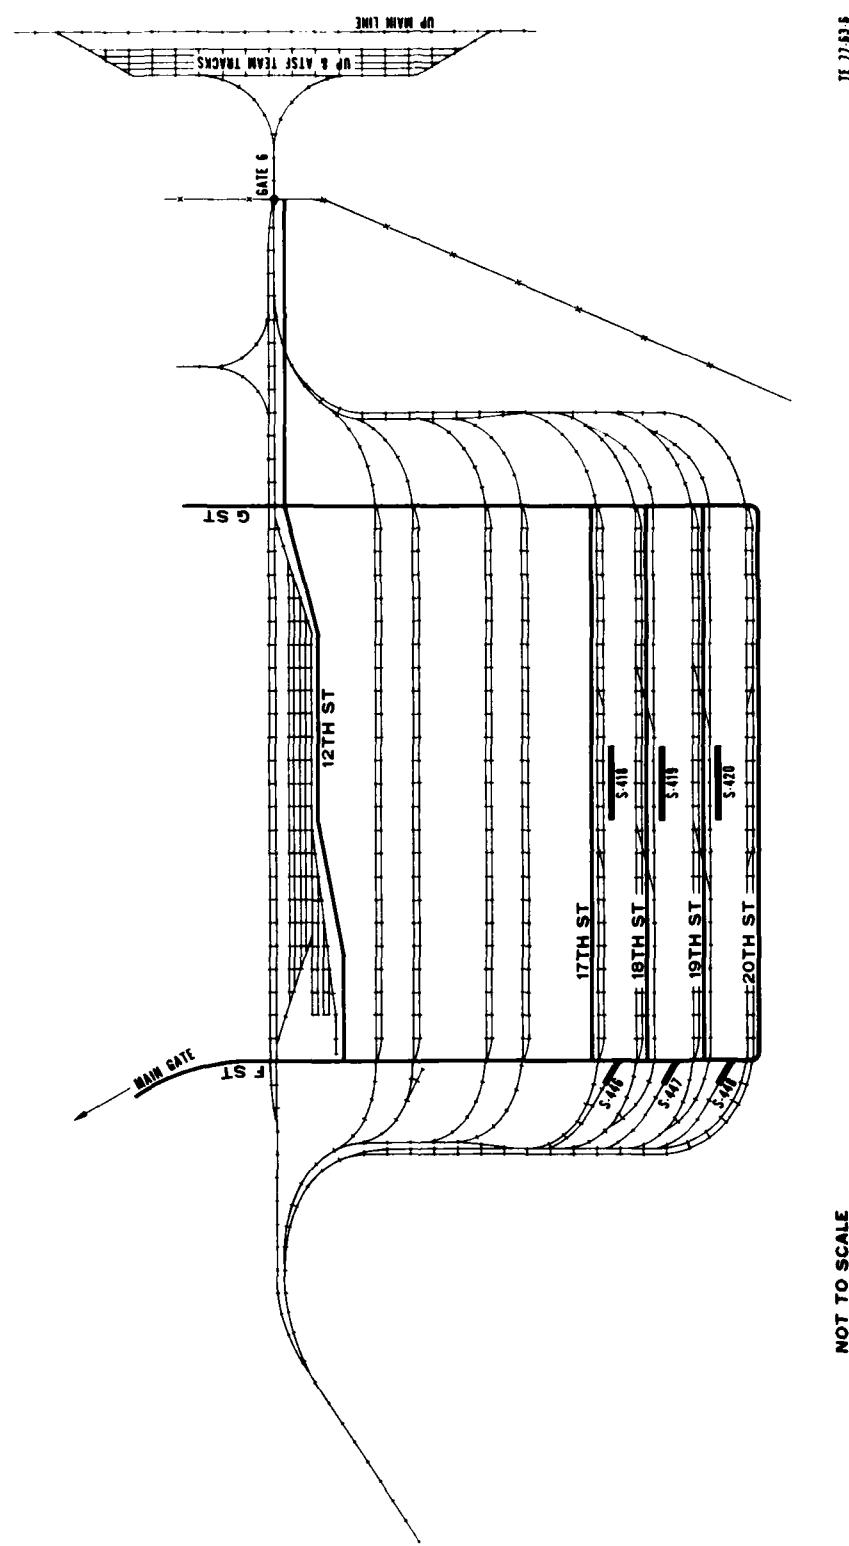
Figure 28. USMC Yermo site plan.

The US Marine Corps Supply Center consists of two locations--Yermo and Nebo. Yermo is 9 miles due east of Barstow along I 15 and old Route 466 and 45 miles from Fort Irwin. About 20 miles of trackage is located on this base (fig 28). Rail service to this base is provided by the Union Pacific Railroad Company, and the base has its own switch engine and rail crew. This base has only three spurs (S-446, S-447, and S-448), located along the northwest portion of the base, with an end-loading capability. One spur (S-446) has a bilevel/trilevel ramp. These spurs have a combined capacity of twenty-three 60-foot cars. The surface around the spurs is hard sand and asphalt, and the staging area is good. Since the asphalt street is immediately adjacent to the ramp, tracked vehicles cannot be loaded at these spurs. The track is in excellent condition (figs 29 through 32).

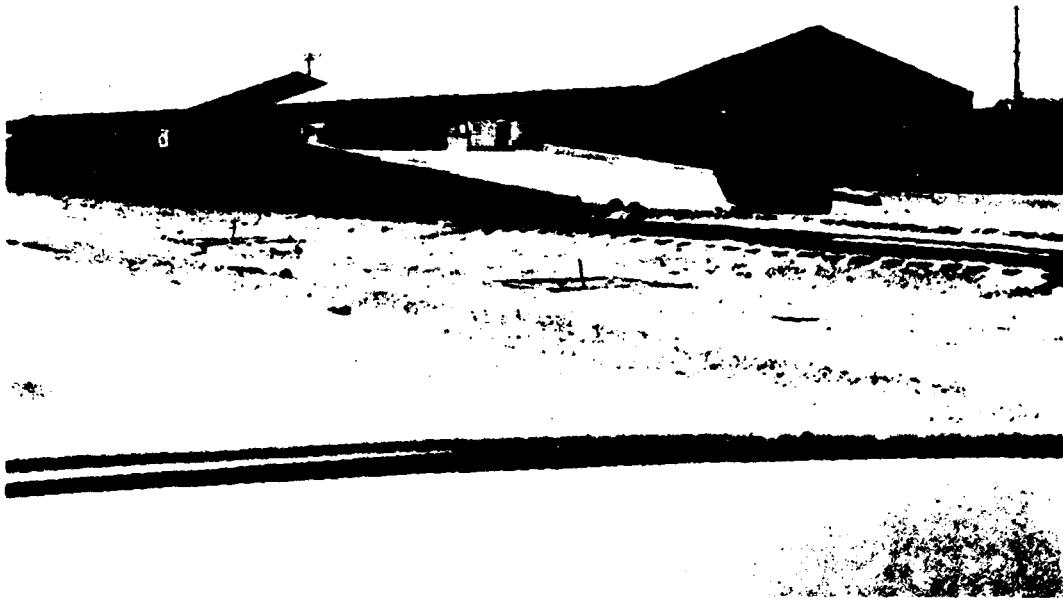
Figure 35. Side-loading ramp at 19th Street, USMC Yermo  
(looking southeast).

Other usable facilities on this base are the three side-loading ramps along 17th, 18th, and 19th Streets (figs 33 through 35) and two tracks north of 12th Street, which are serviced by a heavy-duty straddle crane (fig 36). Also two portable steel end-loading ramps are available (fig 37). These sites were not considered in the simulation because of expected Marine Corps priority during mobilization. The heavy-duty straddle crane would be most useful for loading tracked vehicles. In the past, Fort Irwin has had some tracked vehicles loaded onto/unloaded from trucks by the crane and has reimbursed the Marine Corps for the service. The vehicles are transported over the highway to and from Fort Irwin. The vehicles are loaded/unloaded at Fort Irwin by motor end-loading ramps. If the Army were permitted to use the heavy duty crane during mobilization, further study of the movement of tracked vehicles to this facility is warranted.

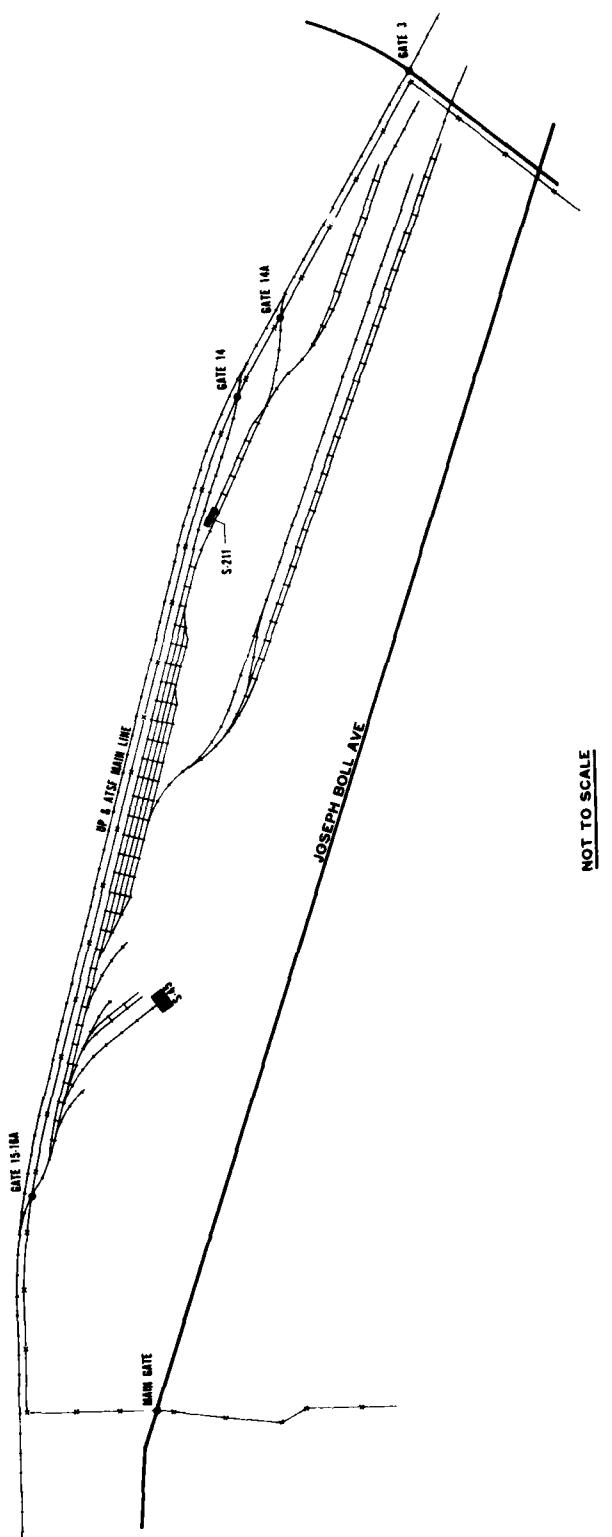
Figure 38. USMC Nebo site plan.

The USMC Supply Center at Nebo (fig 38) is 5 miles east of Barstow along old Route 66 near Interstate Route 40. About 7 miles of trackage is located on this base. Service to this base is provided by the ATSF Railroad. Two spurs are available for end loading. The capacity of track S-211 is fifteen 60-foot cars. The track is in excellent condition, the staging area is good, and the ramp is concrete (fig 39).

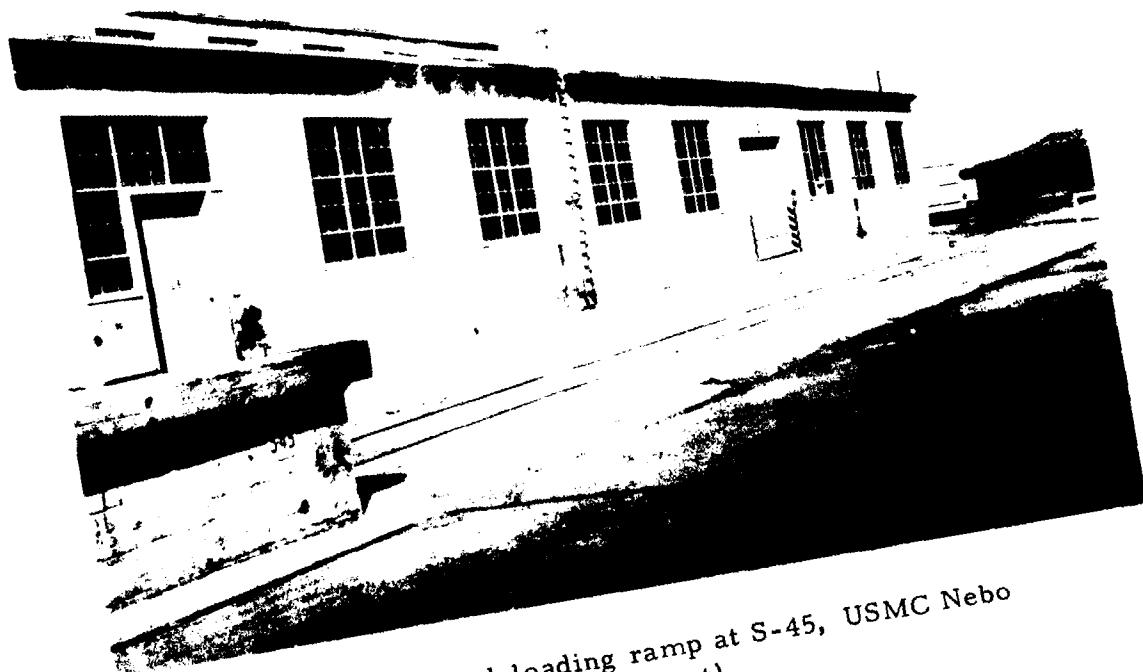
Figure 40. End-loading ramp at S-45, USMC Nebo  
(looking northwest).

Track S-45 has a capacity of five 60-foot cars, a good staging area, a concrete ramp, and it is in excellent condition, figure 40. Access to Nebo is by old Route 66 near I 40 and a minor road from Marine Corps Yermo. Again, coordination with the Marine Corps is necessary for Army use of this installation in case of mobilization.

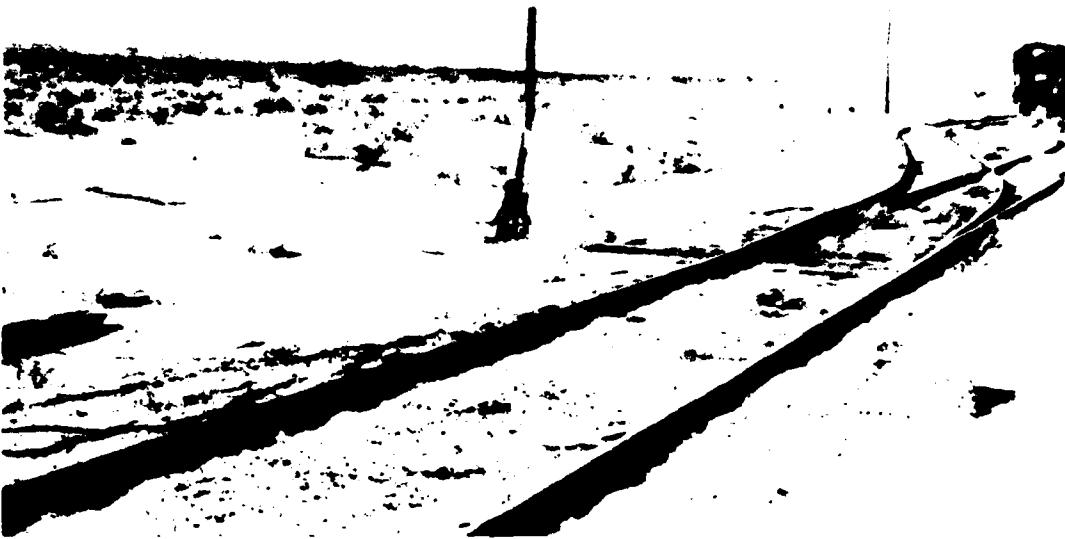
Figure 46. Daggett Airport (looking northeast).

Daggett Airport, about 13 miles east of Barstow along old Route 66 in the Mojave Valley, is 15 miles southwest from Manix. Service is provided by the ATSF Railroad. This site consists of two spurs connected to the main line by a winding section of track on the northern side of the airfield. This track splits into two spurs--a northern spur with no ramp and a continuing southern spur with a huge end-/side-loading concrete ramp. These spurs are capable of handling eight and fifteen 60-foot cars, respectively. Of course, a portable ramp would be needed on the northern spur. The surrounding surface is lightly graveled sand. No lighting is available, but the staging area is good. The Government presently leases this site to the Railguard Railcar Repair Company. The track is in excellent condition (figs 45 through 49).

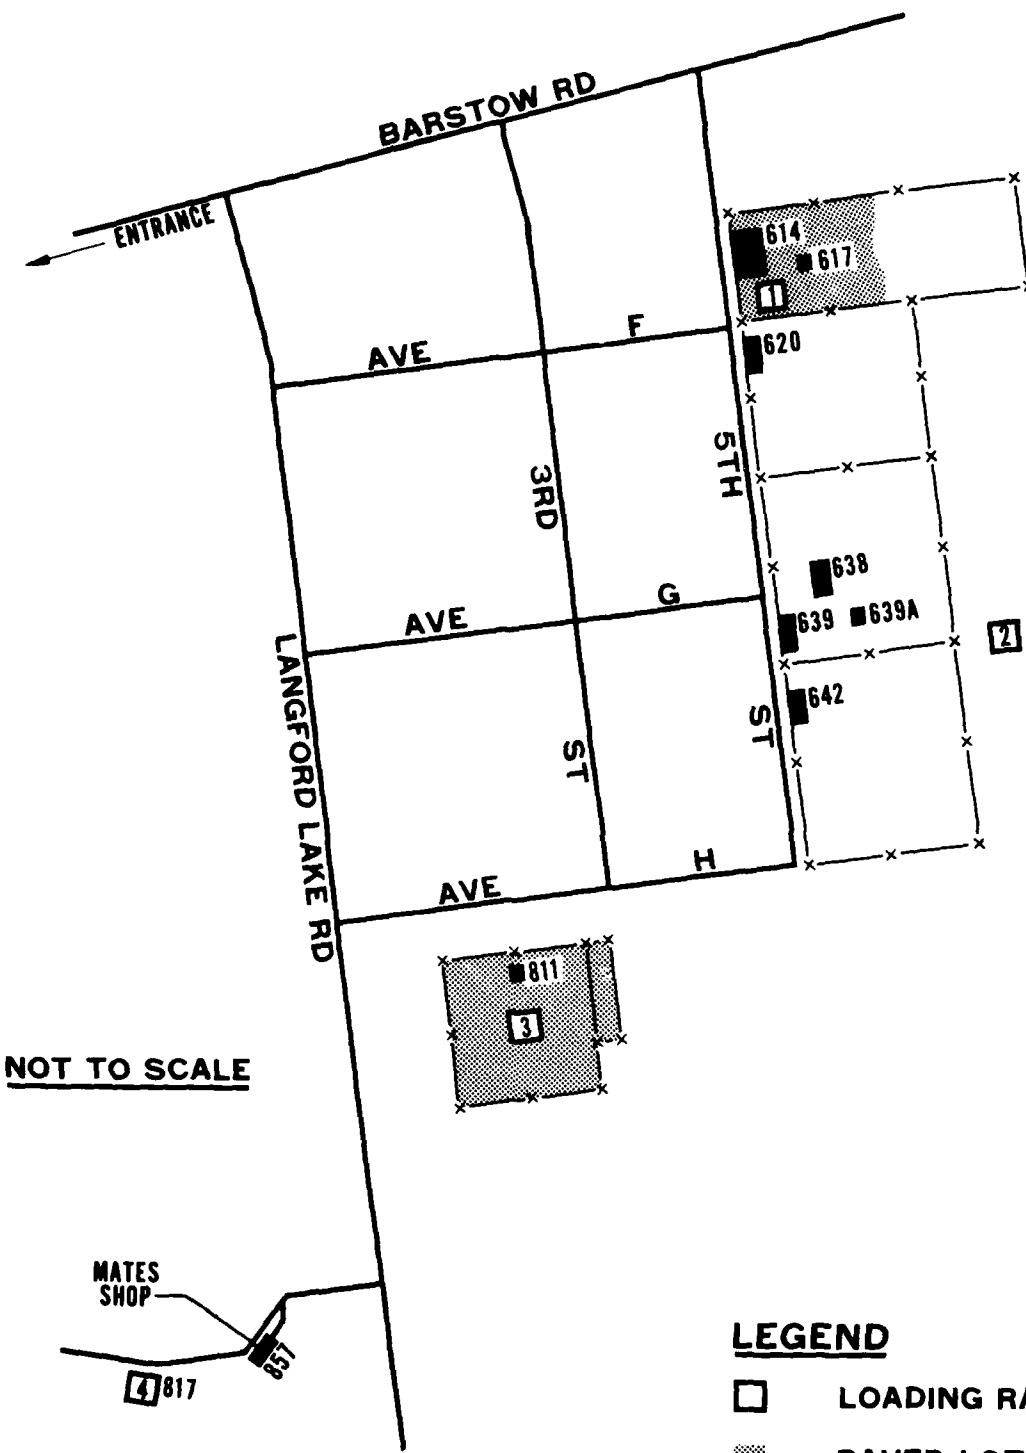
Figure 58. Fort Irwin site plan.

A survey of the motor pool and other activities likely to have suitable end-loading ramps revealed that only four ramps exist (table 15 and fig 58). Ramp 1 (fig 59) is a concrete top on wooden pilings located off 5th Street by Building 614. The others are all concrete and are located as shown in figures 61 through 63. The surface conditions, staging areas, and access to all of these ramps are excellent.
